STRESS CORROSION CRACKING OF TYPE 304 STAINLESS STEEL

STATUS REPORT - MARCH 1, 1964

M. R. LOUTHAN, JR.

Savannah River Laboratory

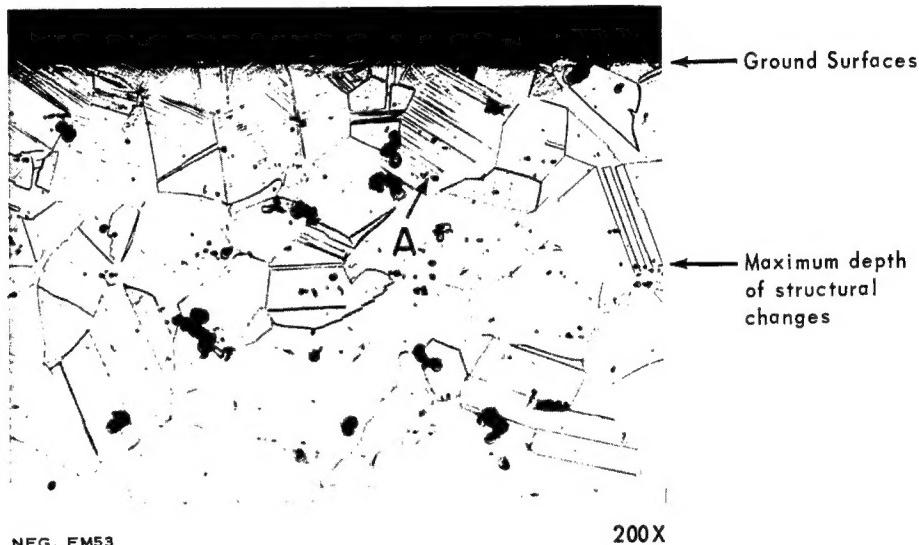
FIG. 1 STRUCTURAL CHANGES ACCOMPANYING DRY GRINDING
Note strain markings, such as shown at A, in the grains near the surface.

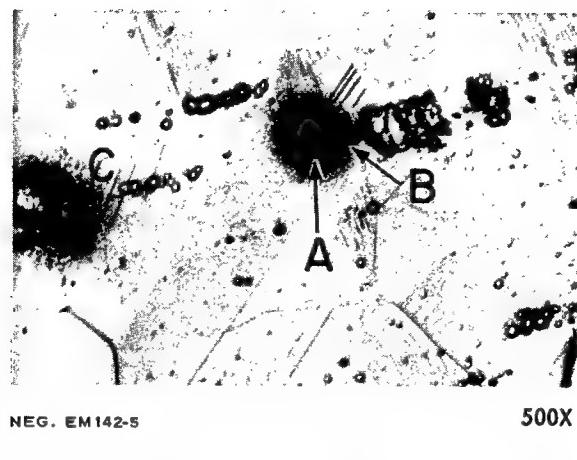
NEG. EM142-5

FIG. 2 DARK CORROSION AREA BEGINNING TO FORM AT INCLUSION
 Region A is the inclusion and region B the corrosion area. Additional corrosion buildup at another inclusion can be seen in region C.

dry-ground surfaces to several hundred hours for polished-and-etched surfaces. Reflection electron diffraction patterns from these corroded areas showed the presence of both Fe_2O_3 and MnFe_2O_4 (Table II), suggesting that the inclusion associated with the corrosion was MnS. The

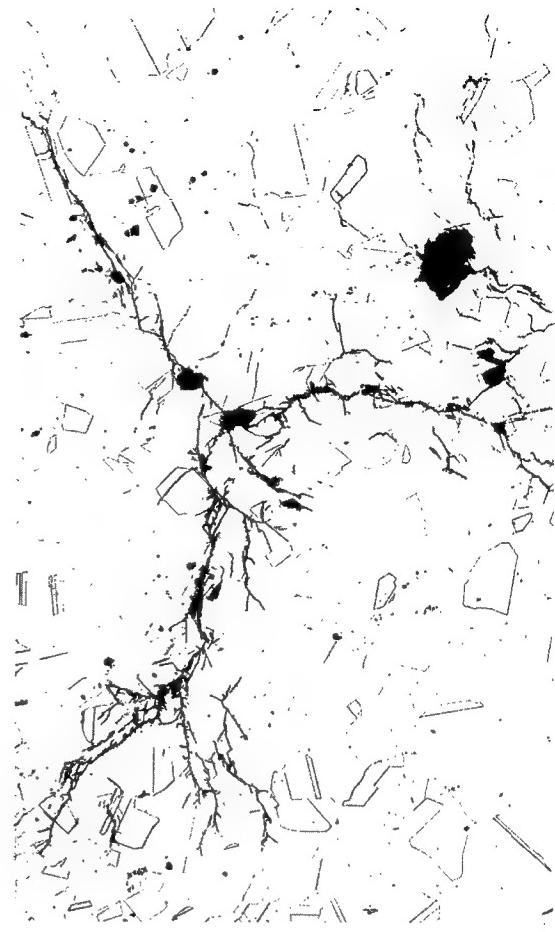
The cracks in the dry-ground samples were principally transgranular and formed pronounced Widmanstätten patterns in several cases (Figure 4). Grain boundary and twin boundary cracking were also observed in limited regions (Figure 3).

- c. Note that the cracks often change directions at grain and twin boundaries.
(Specimen polished perpendicular to the sample surface.)

- b. Note the pits associated with cracks.
(Specimen polished parallel to the sample surface.)

FIG. 4 TYPICAL STRESS CORROSION CRACKS IN GROUND SAMPLES

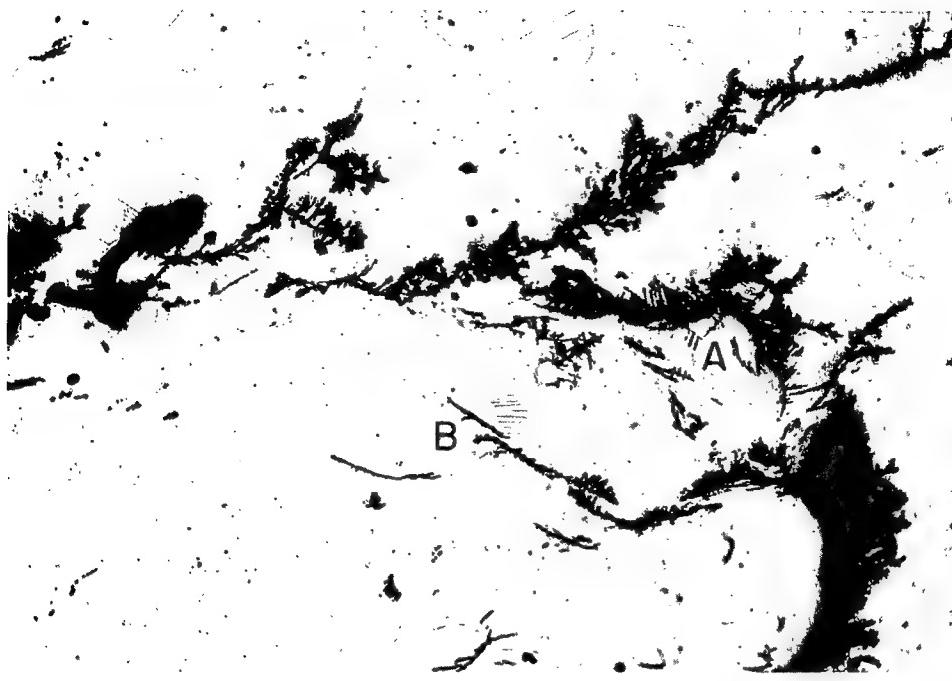
NEG. EM18

FIG. 5 RELATIONSHIP BETWEEN STRAIN MARKINGS RESULTING FROM DRY GRINDING AND THE DIRECTION OF CRACK PROPAGATION

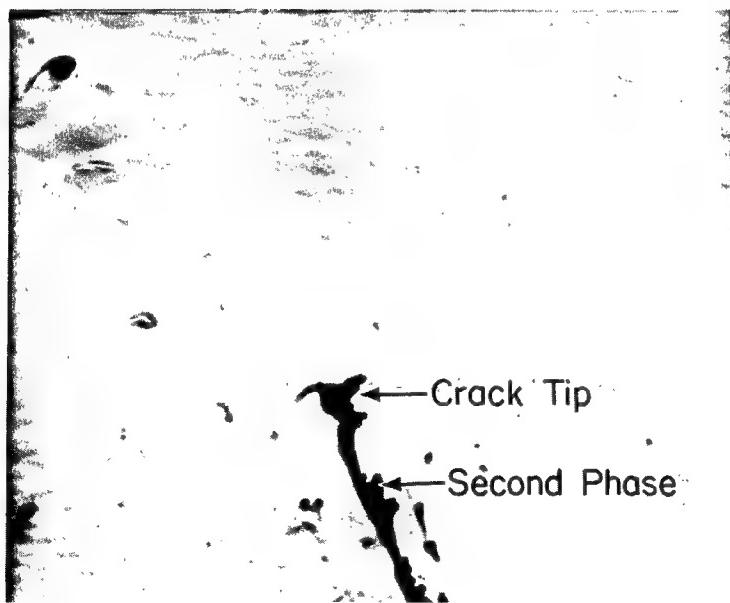
NEG. 1523A

FIG. 6 TIP OF STRESS CORROSION CRACK IN TYPE 304 STAINLESS STEEL. Note the indication of a second phase along the crack wall.

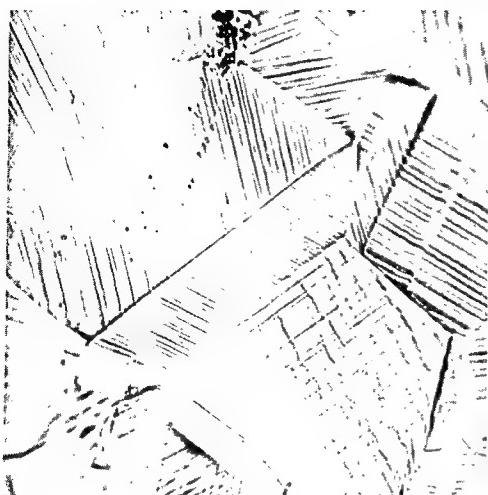
- a. Initial pitting in very localized regions. Exposure 5 minutes.

- b. Extension of pits to form linear traces of corrosion parallel to slip lines. Exposure 15 minutes.

- c. Initiation of cracks (dark centers) within lines of corrosion. Several cracks have joined to form a single branched crack in the center of the field. Exposure 15 minutes.

- d. Pattern of well-developed cracks. Exposure 30 minutes.

FIG. 8 SEQUENCE OF CRACK INITIATION IN TYPE 304 STAINLESS STEEL U-BEND SPECIMEN IN BOILING $MgCl_2$

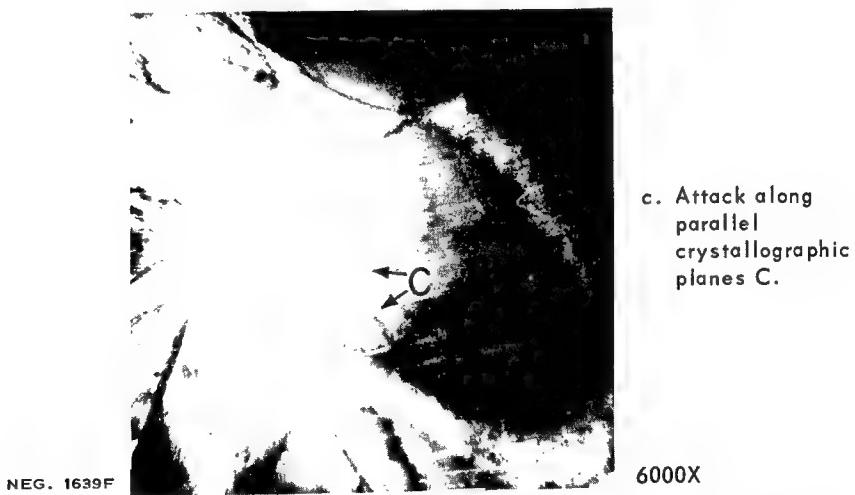
The electropolishing caused preferential chemical attack to occur at stacking faults, grain boundaries, and along certain crystallographic planes (Figure 9). This preferential attack was not noted in all regions, but occurred to some extent in almost every sample. The stacking faults were generally more reactive than the other sites of preferential attack and in some cases were completely dissolved.

a. Attack at a stacking fault A.

b. Attack along a grain boundary B.

FIG. 9 TRANSMISSION ELECTRON MICROGRAPHS OF ELECTROPOLED TYPE 304 STAINLESS STEEL. Note the preferential attack (light, high-transmission regions) at various structural features. This attack was the result of the electrochemical thinning of the foils.

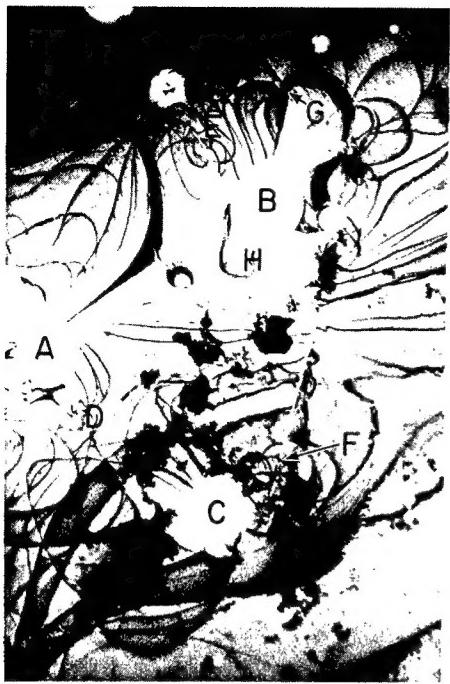
NEG. 1714D

FIG. 11 TIP OF CRACK PRODUCED IN TYPE 304 STAINLESS STEEL FOIL DURING 15-MINUTE EXPOSURE TO DILUTE NaCl SOLUTION AT 100°C. Corrosion product was identified by selected-area electron diffraction in the vicinity of the crack tip and a stacking fault is apparent at A.

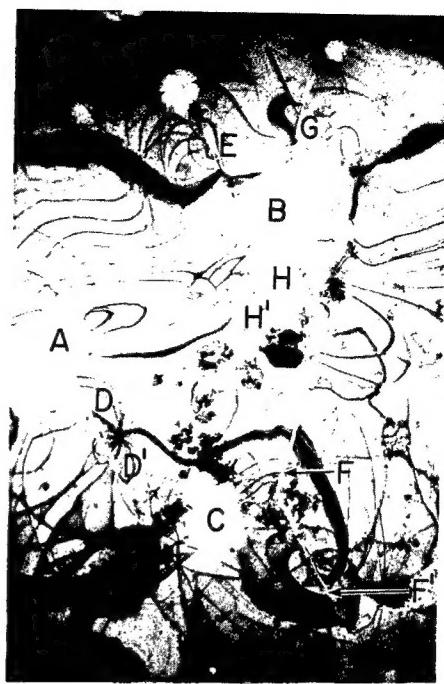
a. After 15-minute exposure.

b. After 25-minute exposure.

FIG. 12 PROPAGATION OF EXISTING CRACKS IN TYPE 304 STAINLESS STEEL FOIL DURING EXPOSURE TO A SOLUTION OF DEIONIZED WATER AND 100 PPM CHLORIDE (as NaCl) AT 100°C. Note that after 15-minute exposure cracks in the foil propagated from holes A, B, and C ended at points D, E, F, G, and H, and that after 25-minute exposure the cracks had propagated to D', E', F', and H'.
